***TESTING OF A WATER TANK  
CONSTRUCTED USING DINCEL WALL  
FOR COMPLIANCE WITH THE  
LIQUID TIGHTNESS REQUIREMENTS OF  
AUSTRALIAN STANDARD 3735***

# **REPORT NUMBER REP03/20180**

### **Prepared For – Dincel Structural Walling**

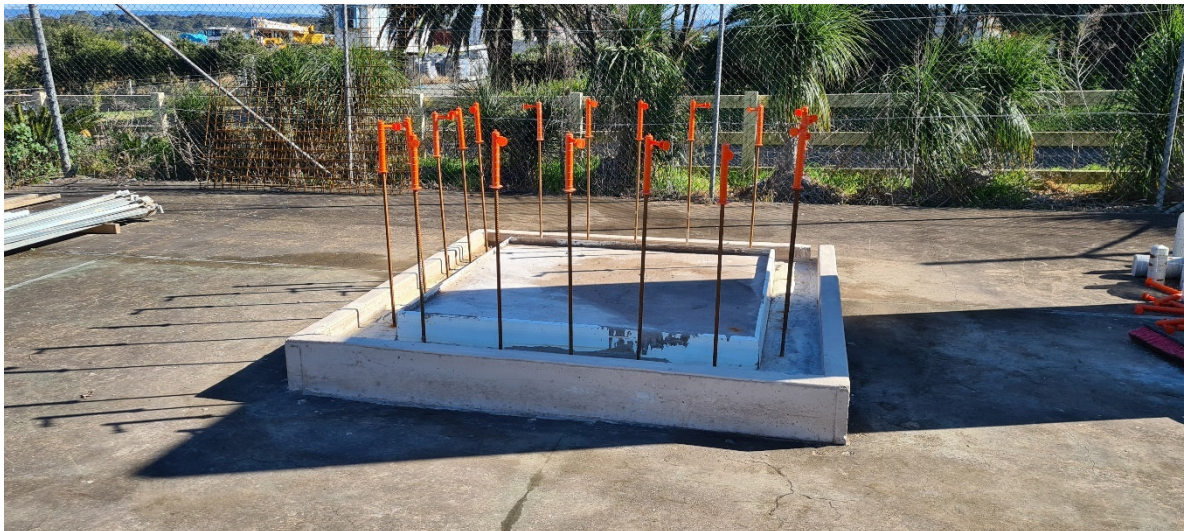
**Photograph 1**

The base slab, showing the vertical embedded reinforcing bars, the panel recess and the vertical flashing at the edge of the recess, is shown in Photograph 1.

It was confirmed that there were 5 vertical bars coming up out of the slab and these were at the spacings nominated on the drawings.

The width and depth of the recess were also measured and these complied with the drawings.

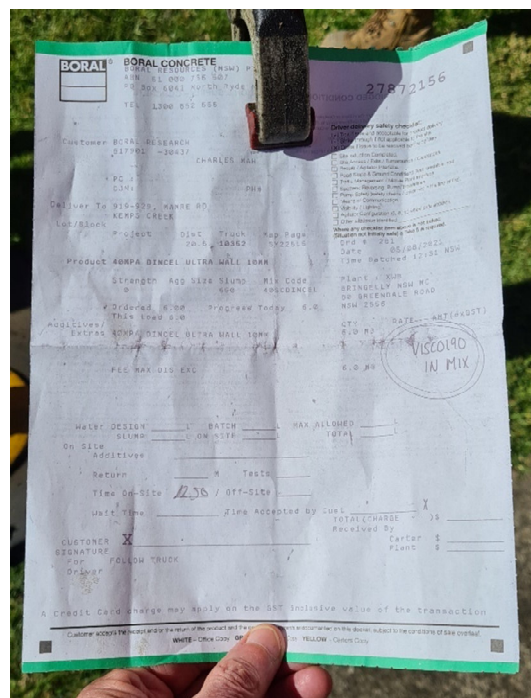
The concrete used in the work was specified on drawing 1 as Boral SCC227669, 10mm agg, 40MPa. The delivery docket for the concrete placed into the walls is shown in Photograph 2 and the mix details are as follows.

- 40MPa Dincel Ultra Wall 10mm
- Mix Code 40SC Dincel
- Slump 650

The code on the drawing does not appear on the delivery docket, however, the key requirements for the concrete can be seen on the delivery docket. In particular, the 10mm aggregate, strength of 40MPa and the SCC notation, indicating self compacting concrete.

The spread of 650mm (shown as slump on the docket) is consistent with self compacting concrete.

On this basis, the concrete ordered was consistent with the mix on the drawing.

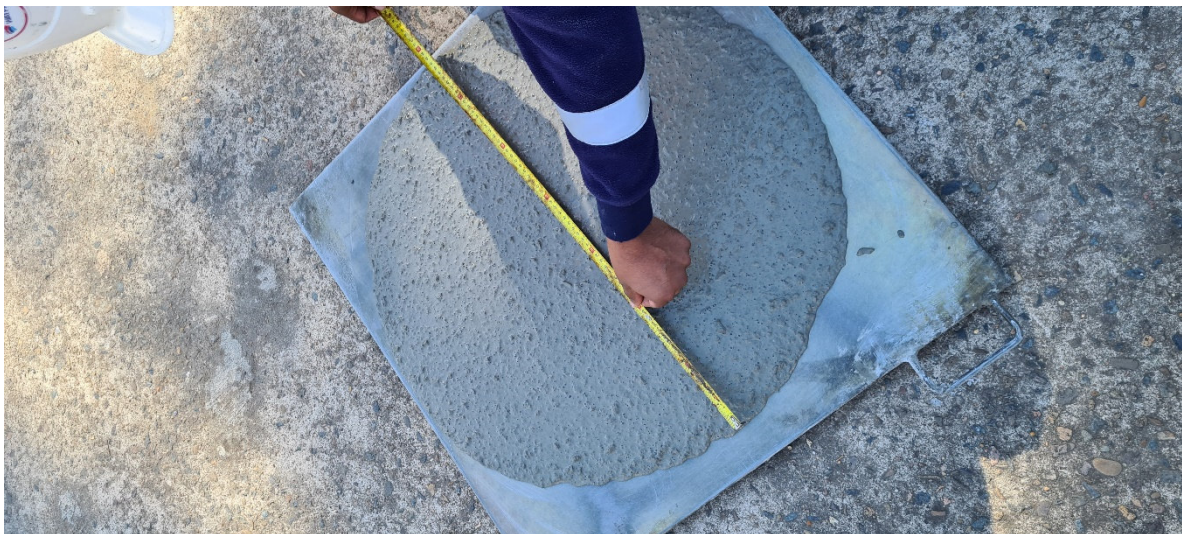
**Photograph 3**

Prior to placing, the concrete was tested for slump/flow, and the spread of the concrete was 670mm (see Photograph 3). 670mm complies with a nominated spread of 650mm, within the tolerance of  $\pm 50$ mm nominated in ASTM C1611.

There was no evidence of segregation during the slump flow test.

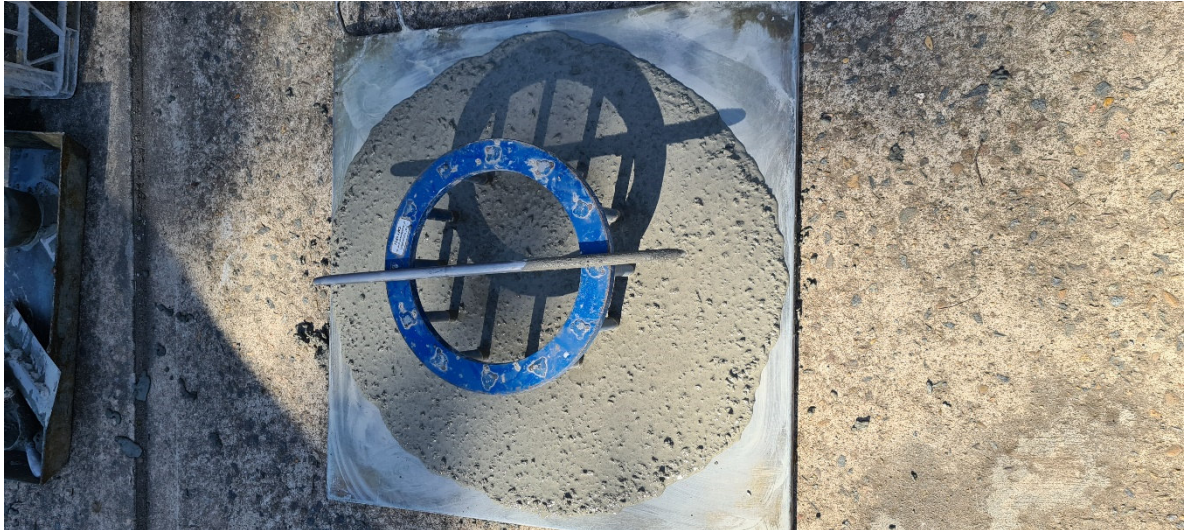
**Photograph 4**

J-Ring testing was also undertaken and there was no difference in height within and just outside the J-Ring (see Photograph 4).

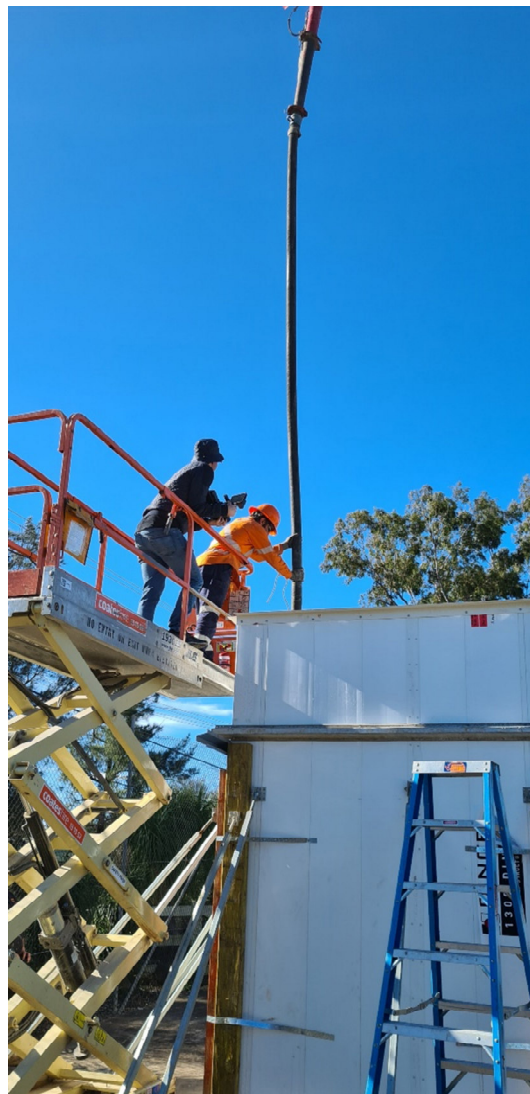
**Photograph 5**

On completion of the testing, the concrete was pumped into place (see Photograph 5).

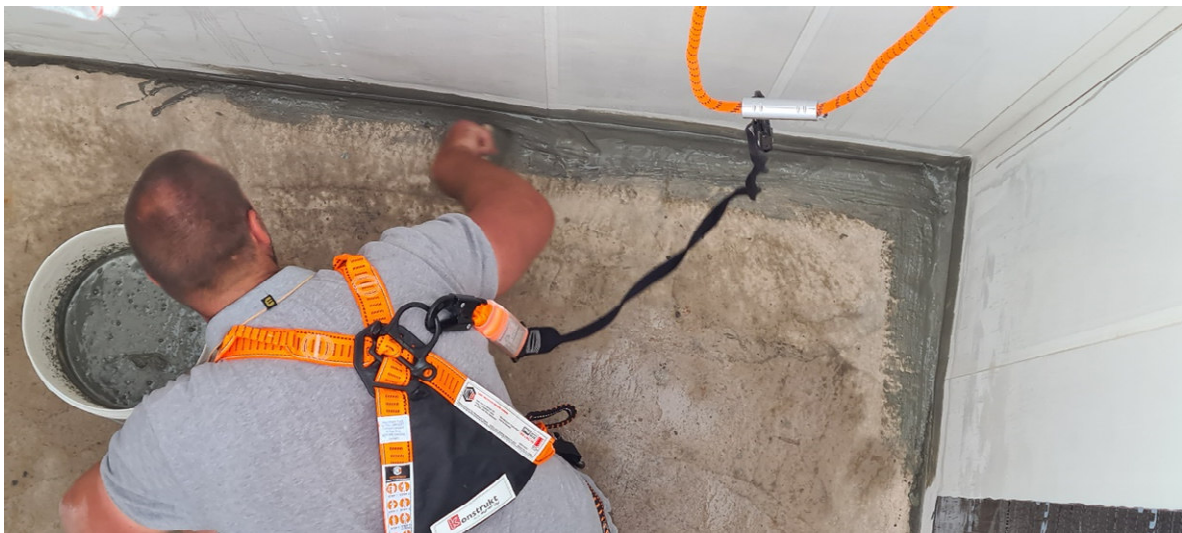
**Photograph 6**

The application of the Hydrostatic 1 is shown in Photograph 6 and the application of the Joint Band is shown in Photographs 7 and 8.

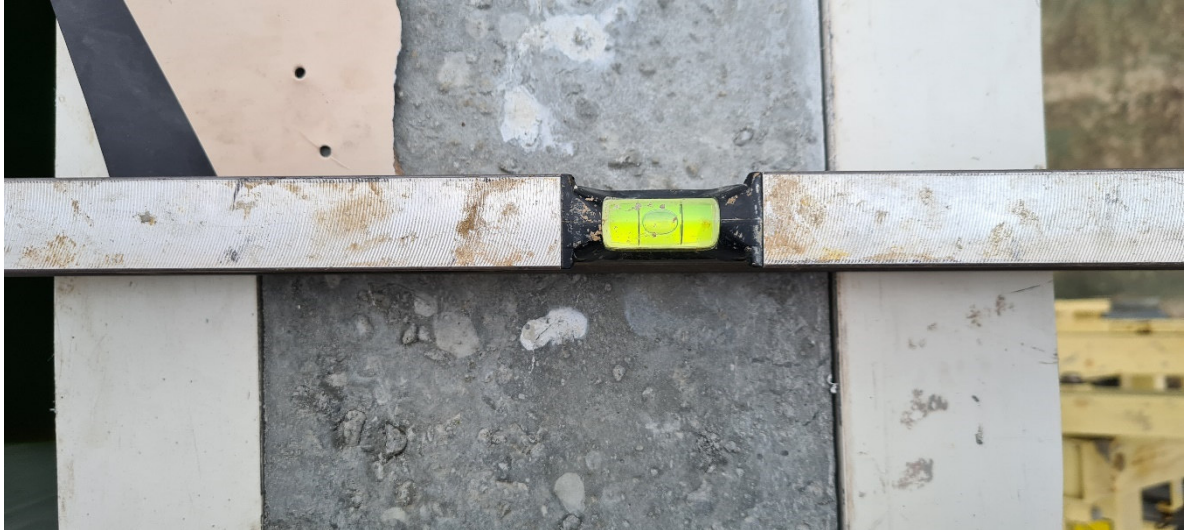
**Photograph 9**

viewing pipe was the same as the water level inside the tank. I again did this by measuring down from the top surface of the tank to the top surface of the water in the viewing pipe. I placed a spirit level on top of the wall to ensure that the measurements down from the surface of the tank on both sides were taken from the same level (see Photograph 9).

- Based on these measurements, I can confirm that the water level in the tank and the water level in the viewing pipe were the same.
- To ensure that there was a direct connection between the water in the tank and the water in the viewing pipe, I asked that some additional water be added to the tank. I then checked that the water level in the viewing pipe rose by the same amount as the water level in the tank.

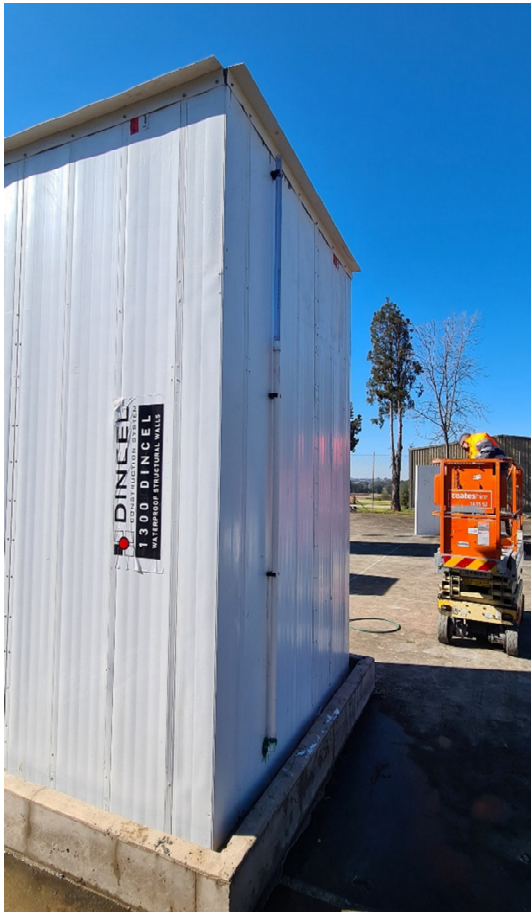
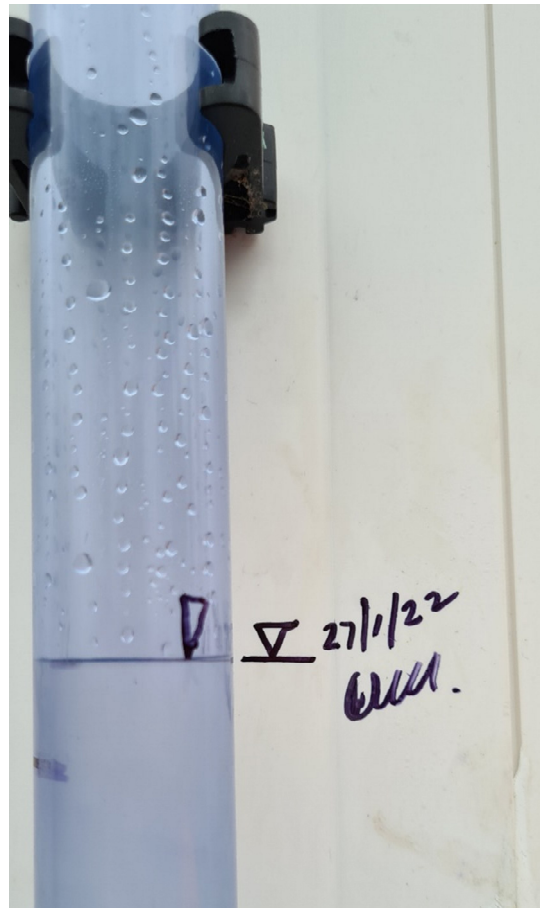
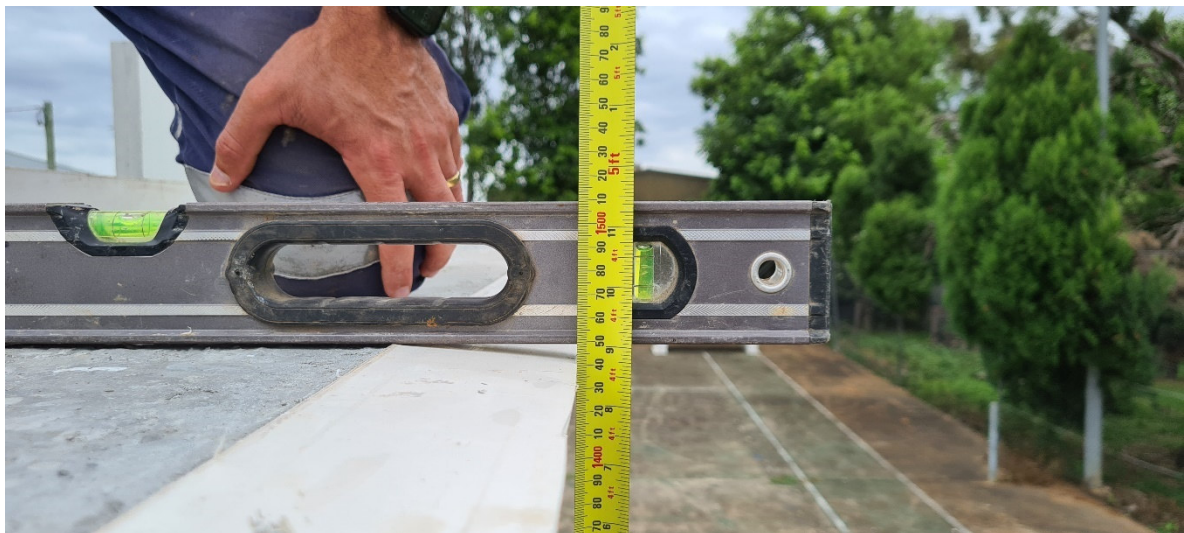
- The viewing pipe can be seen in Photograph 10 and the water level, marked on the viewing pipe, as well as my initials on the wall behind, is shown in Photograph 11. The water level was 1,449mm down from the top of the tank (see Photograph 12). As the tank height is 3,200mm, the water level in the tank is 1,751mm.

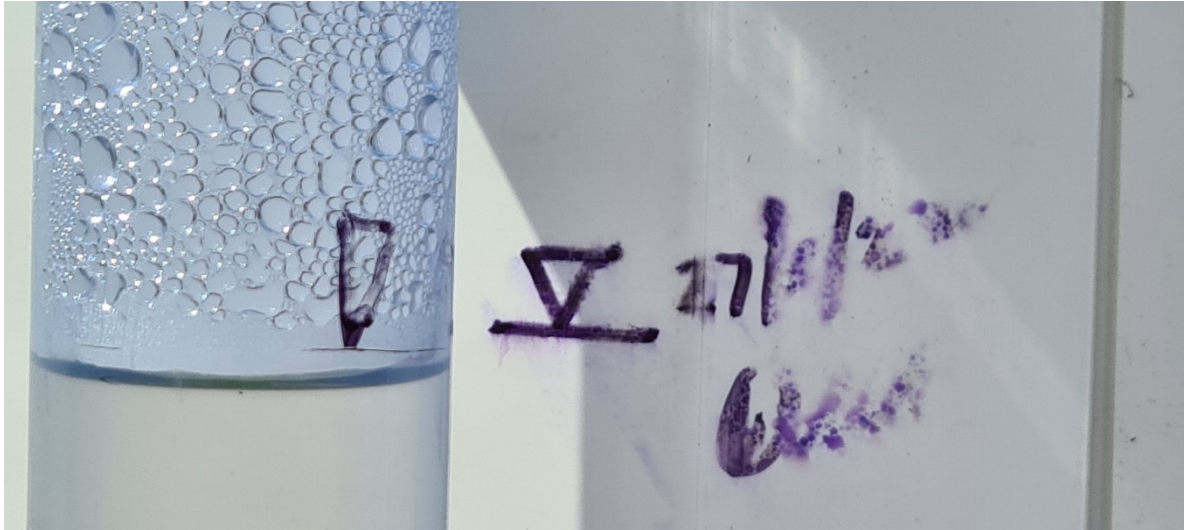
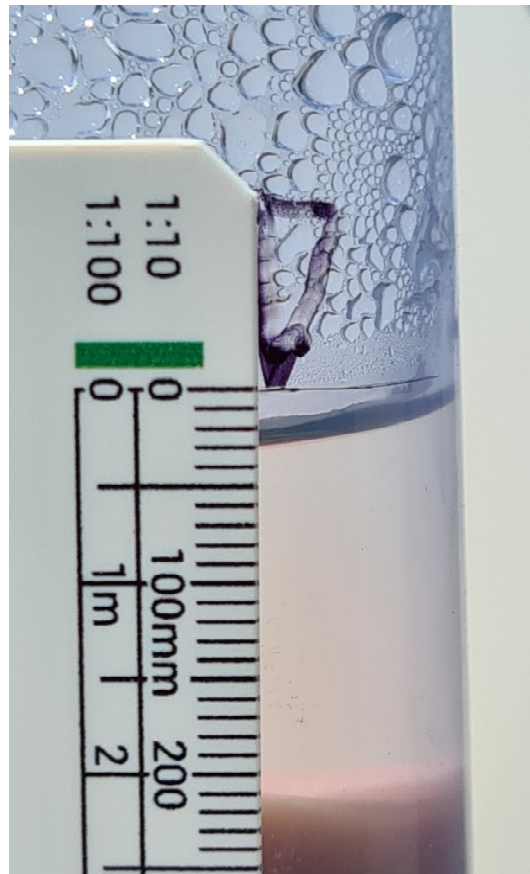
- I photographed the sealant holding the lid in place. Based on a comparison of these photographs with the corresponding photographs I took on 27 January 2022, I can confirm that there is no evidence to suggest that the roof of the tank was removed in the time between my visits. The photographs I took on 27 January are shown side by side with the photographs I took on 3 February in Appendix C. These photographs also confirm that the cap was still in place at the top of the viewing pipe.
- I measured the water level down from the top of the mark on the viewing pipe. The drop in water level from this line was 3mm. The mark on the viewing pipe as well as my initials on the wall of the tank can be seen in Photograph 13. I used a ruler to measure the drop in water level from the initial water level marking to the water level on the day and this was just under 3mm (see Photograph 14).

The drop in water level during the test period was just under 3mm. With the water height in the tank being 1,751mm, the permissible drop is 3.5mm. Therefore, the drop in water level during the test period was less than the permissible level.

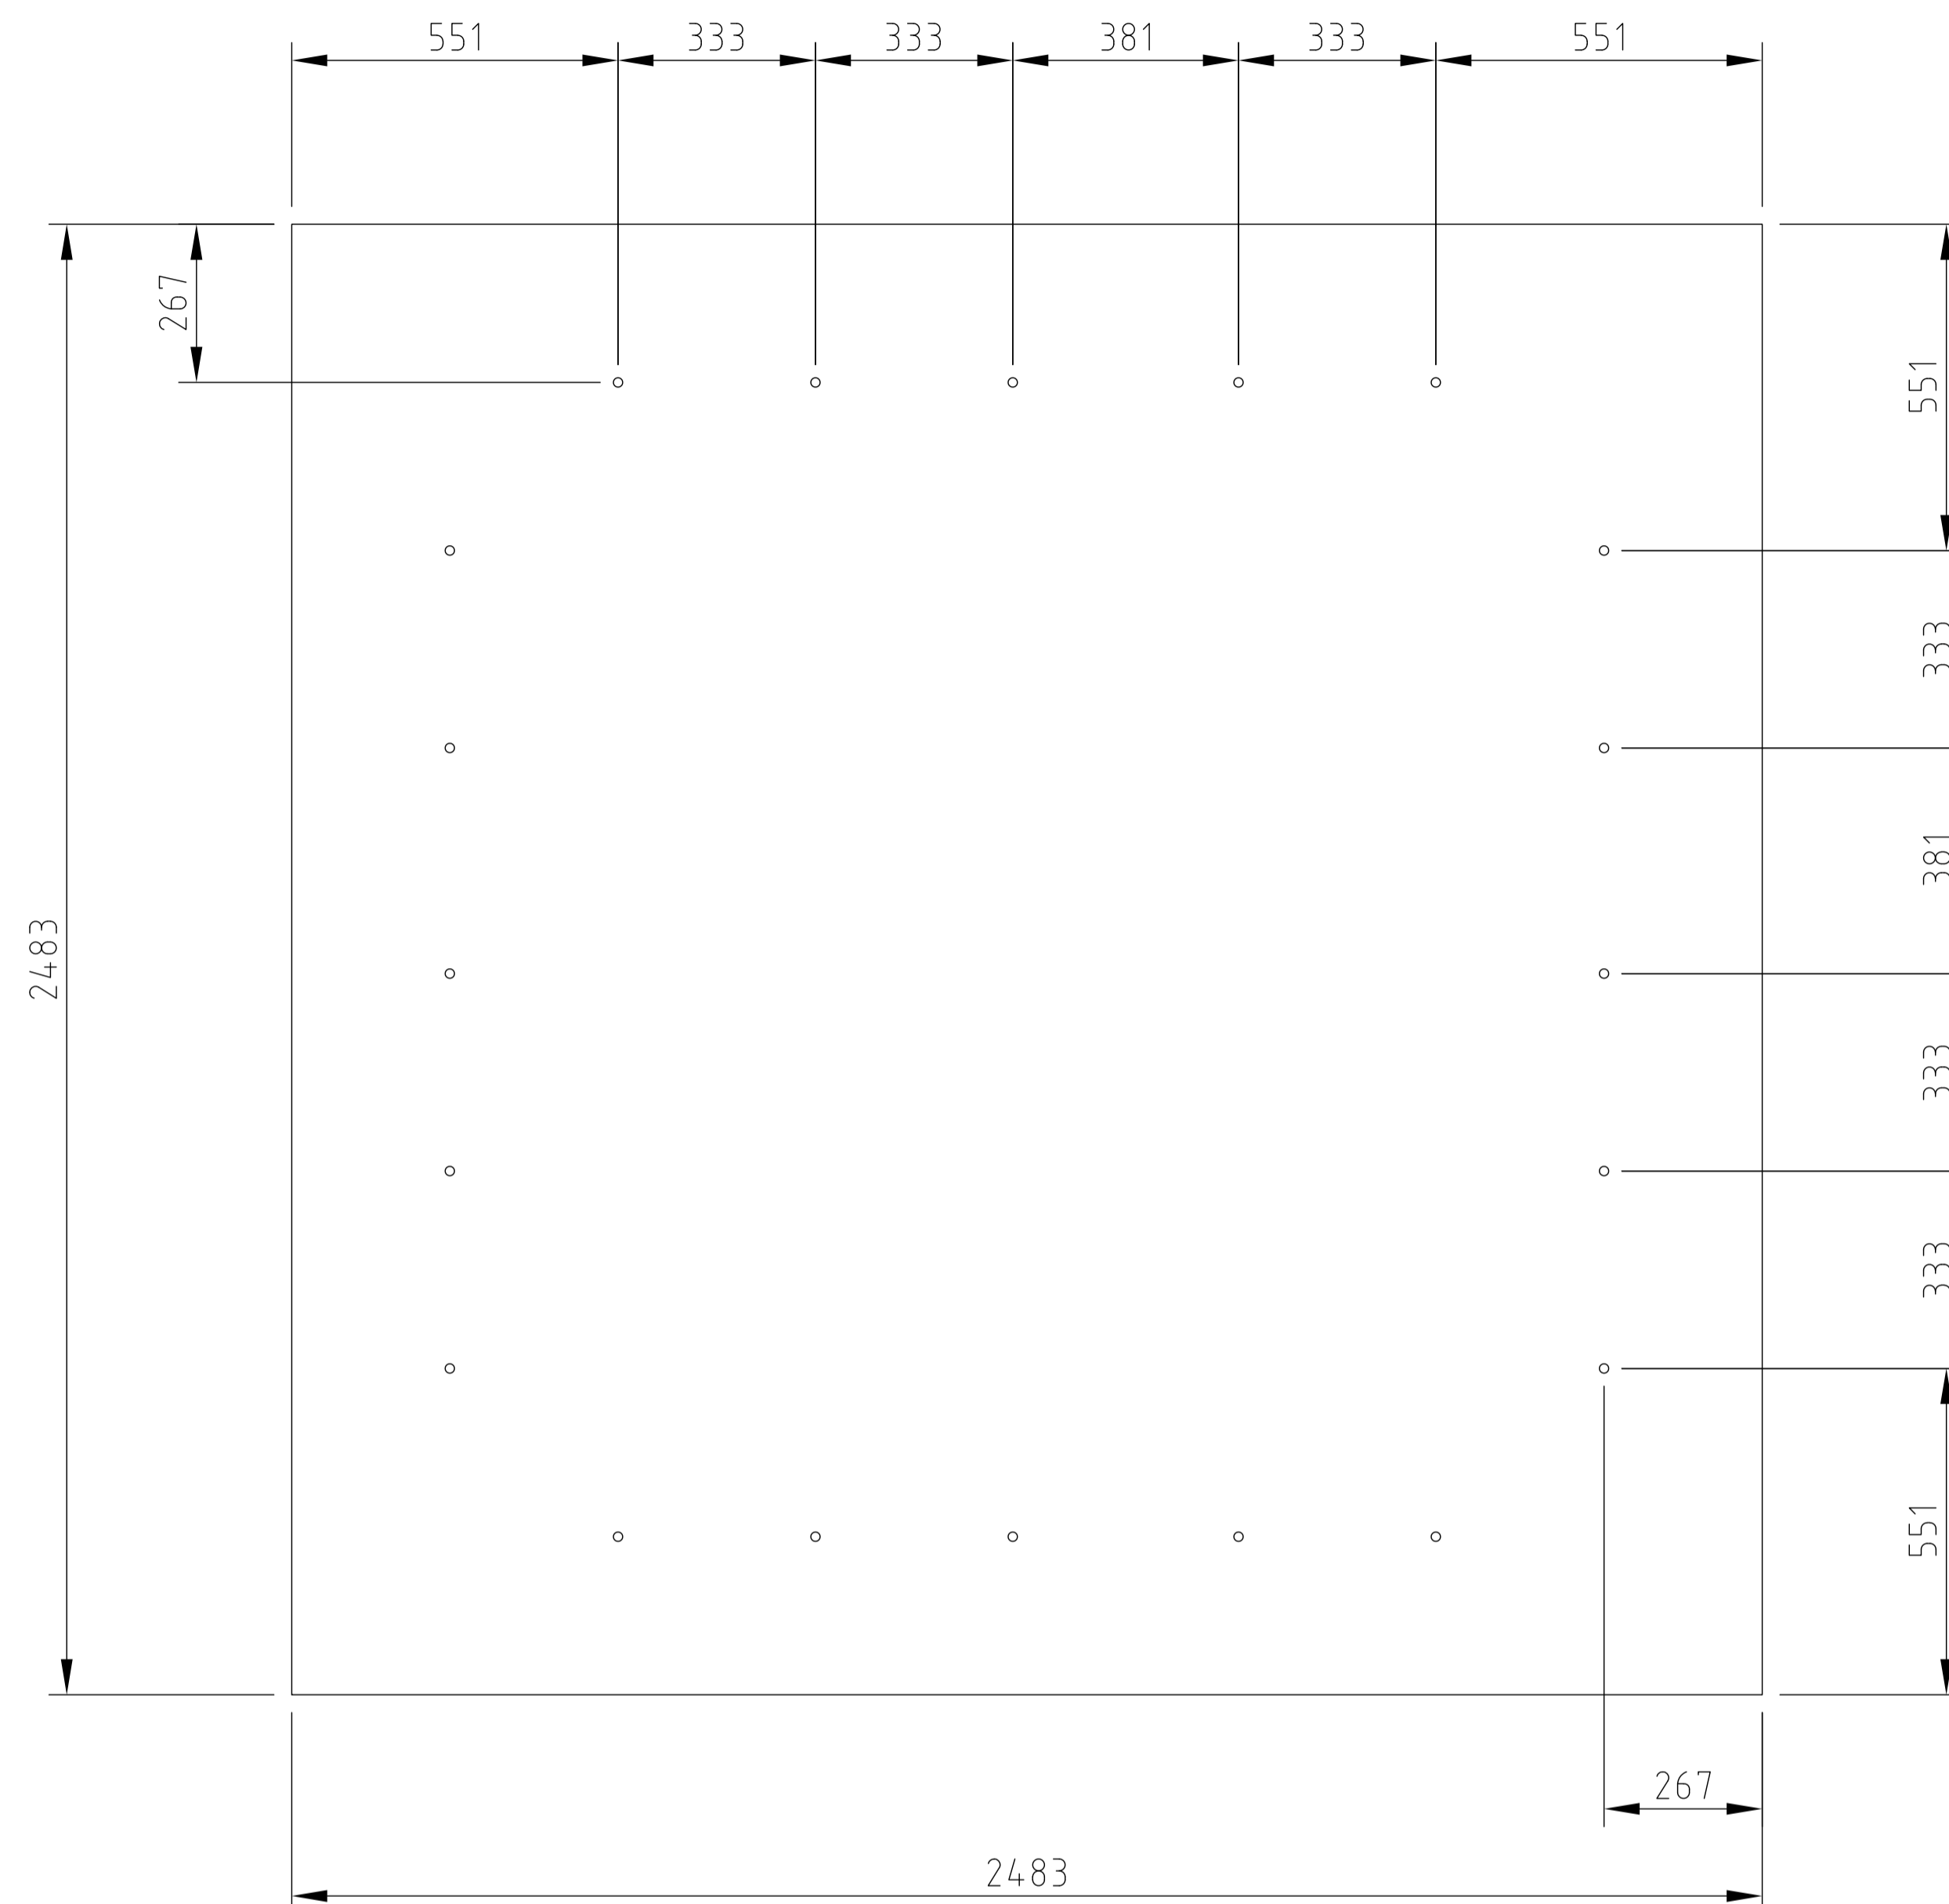
DINCEL 200 TANK TEST  
DRAWING 1

WATERPROOFING PROVIDED WHERE BARB JOINT CANNOT BE UTILISED. AREAS INCLUDE:  
 - P-WS ACCESSORY (@ CUT PANEL) - USE MEMBRANE + SEALANT
