***TESTING OF A WATER TANK  
CONSTRUCTED USING DINCEL WALL  
FOR COMPLIANCE WITH THE  
LIQUID TIGHTNESS REQUIREMENTS OF  
AUSTRALIAN STANDARD 3735***

# **REPORT NUMBER REP03/20180**

### **Prepared For – Dincel Structural Walling**

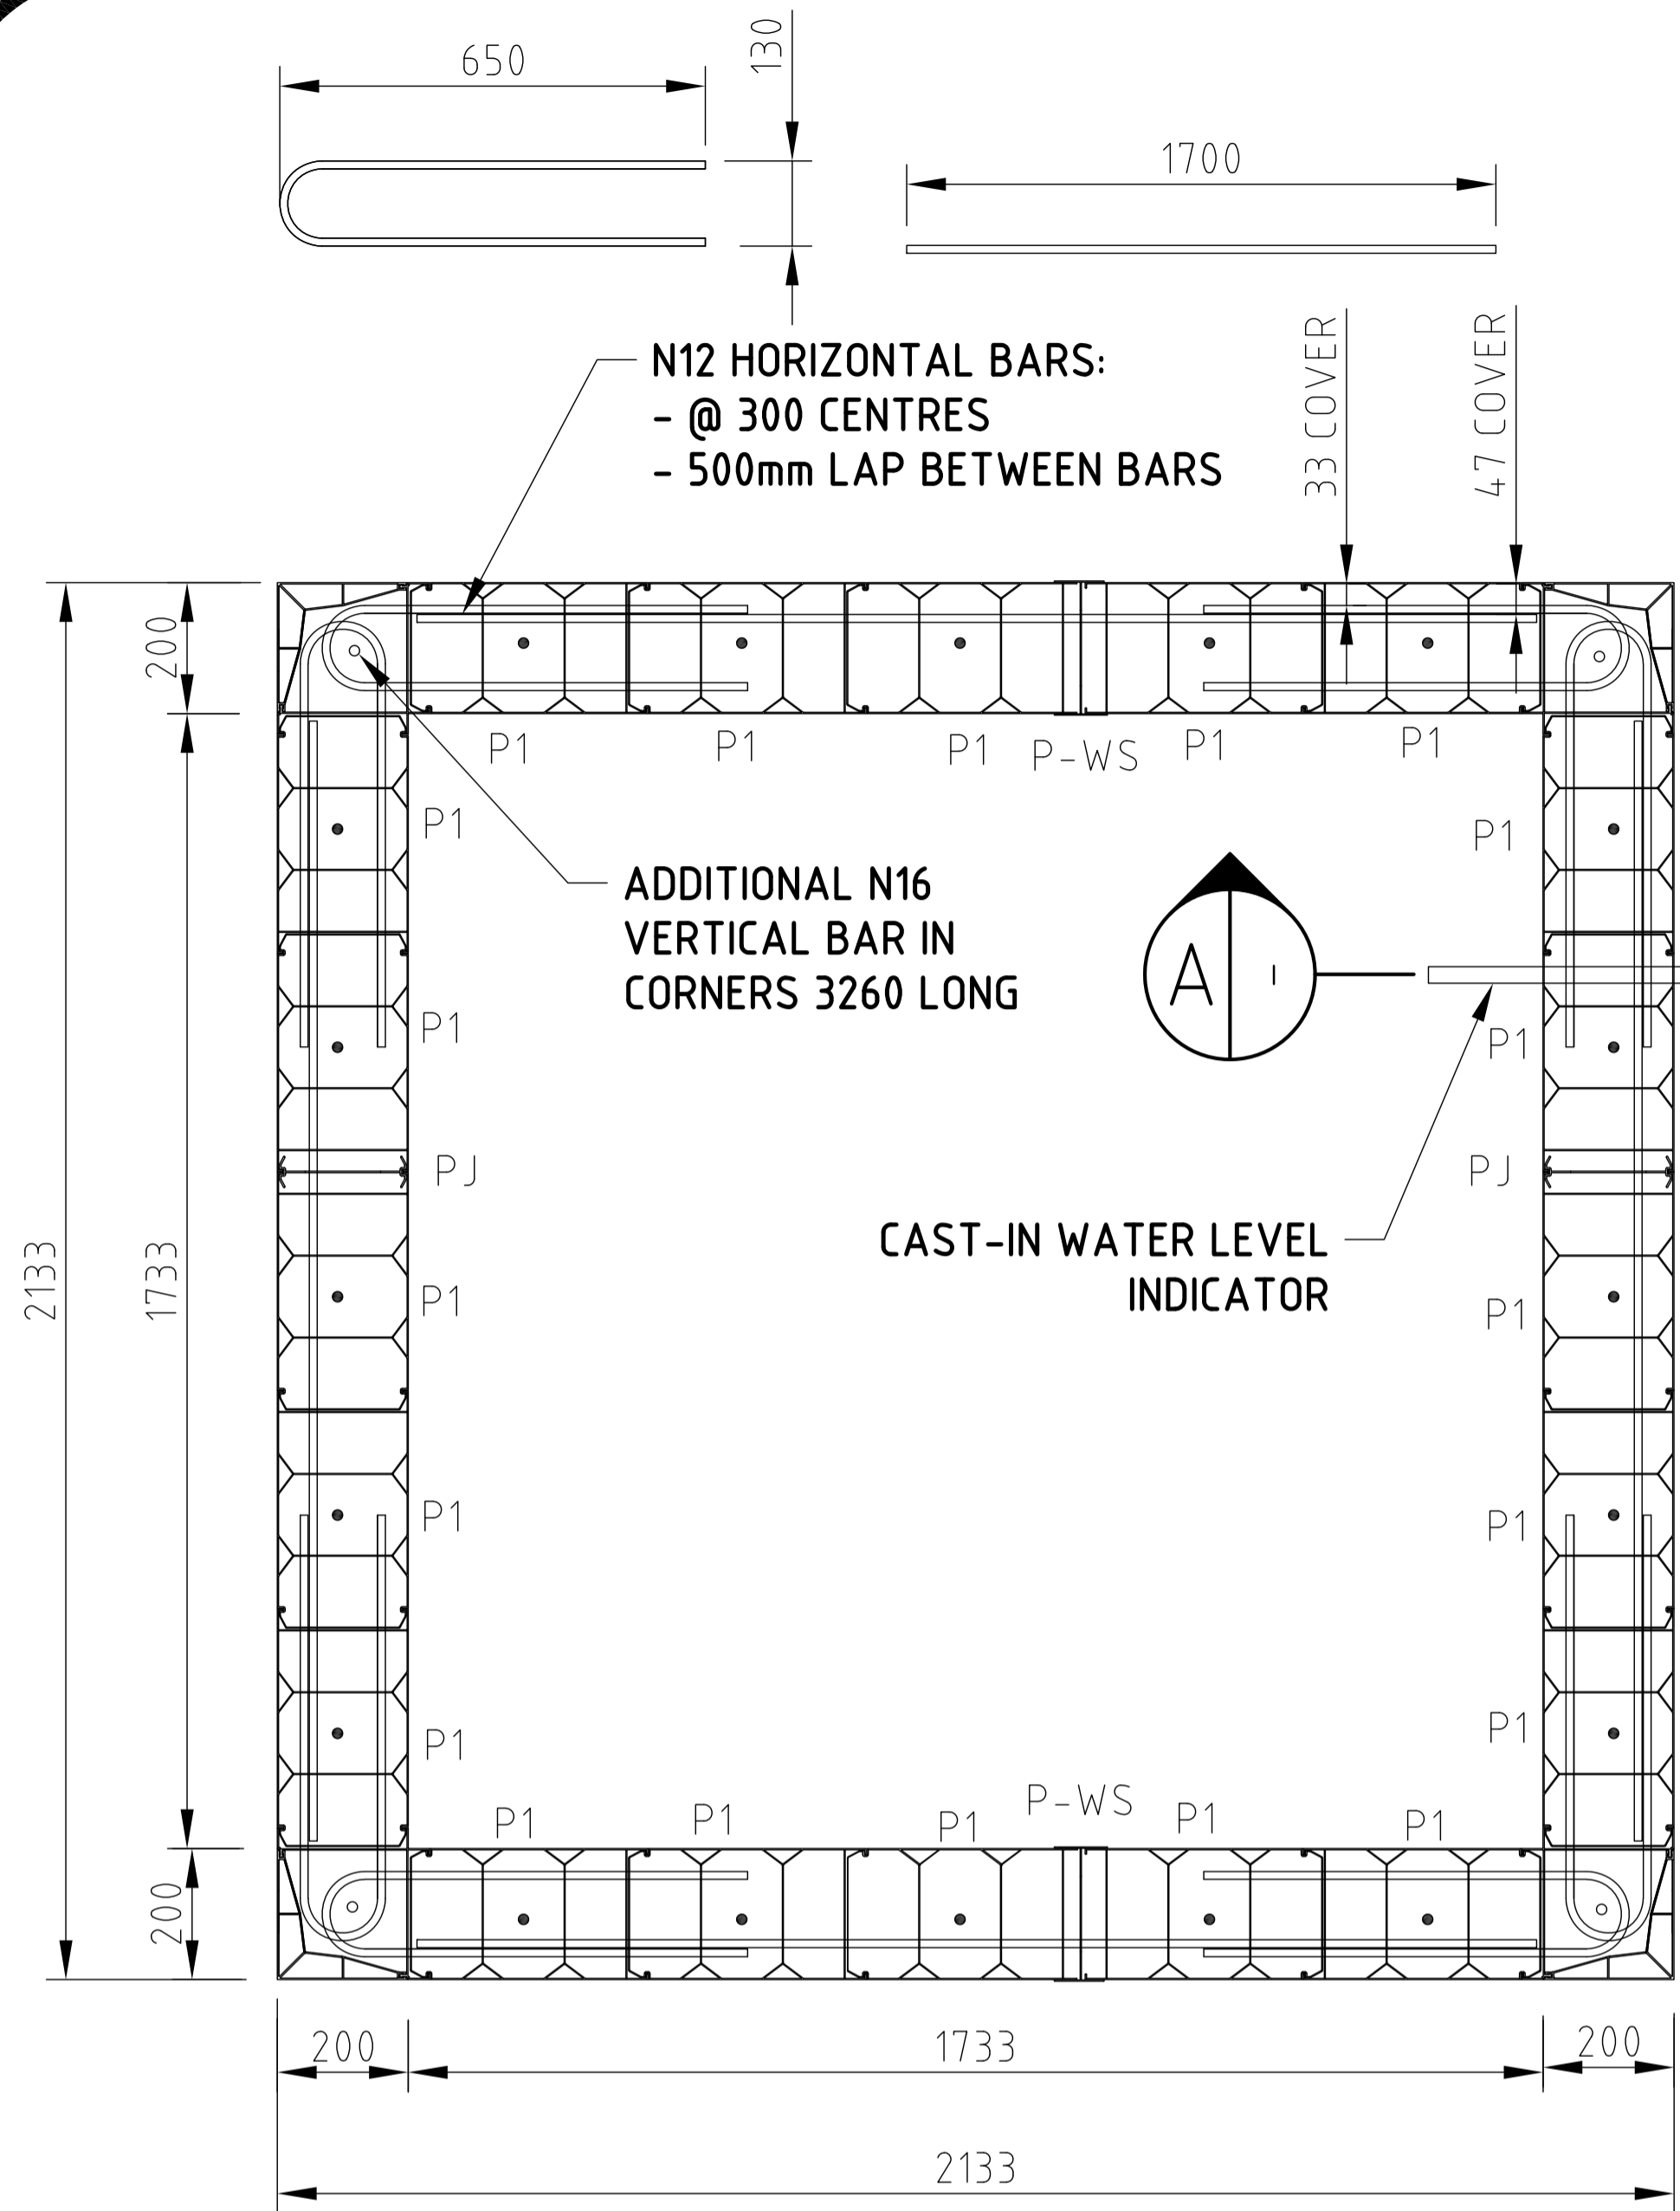
**WALL LAYOUT**

A membrane is shown on the inside face of the tank (W-S Wall Splice Details). This membrane was observed prior to placing of the concrete. The cover plate was also observed on the external face of the wall. This detail was provided on two opposite faces of the tank (locations noted as P-WS on drawing 1).
